General Information

Property Address 1234 Example Street
City Cincinnati State OH Zip 45200
Contact Name
Phone Fax

Inspector Name Maury Drummey, ASHI Certification number 10478, Kentucky Home Inspectors
License number HI-2157
Company Name G. C. Housing Evaluation Service, Inc.
Company Address P.O. Box 8173
City Cincinnati State OH Zip 45208
Phone (513) 871-1998 Fax (513) 533-9330
E-Mail mfd4@aol.com

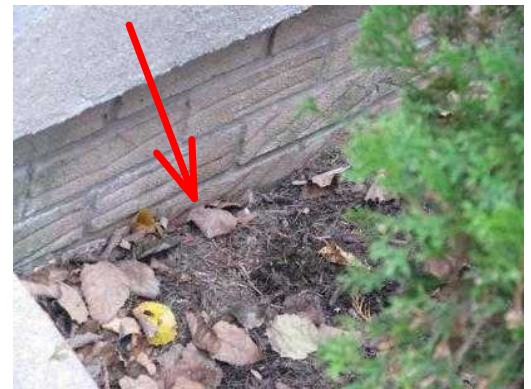
| 13. | <input type="checkbox"/> | <input type="checkbox"/> | <input type="checkbox"/> | <input type="checkbox"/> | <input checked="" type="checkbox"/> | Grading: Contact of the dirt and mulch with the brickwork must be eliminated. This contact creates a situation conducive to insect infestation and/or rot. |

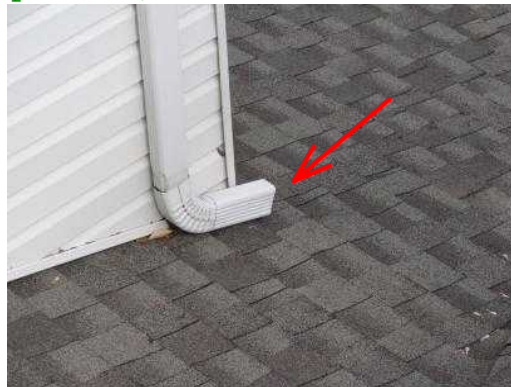
11. Downspouts: Aluminum The northeast down spout should be extended into the drain tile. (First picture). The down spout presently dumping storm water onto the lower front roof should be extended into the lower gutter. (Second picture).

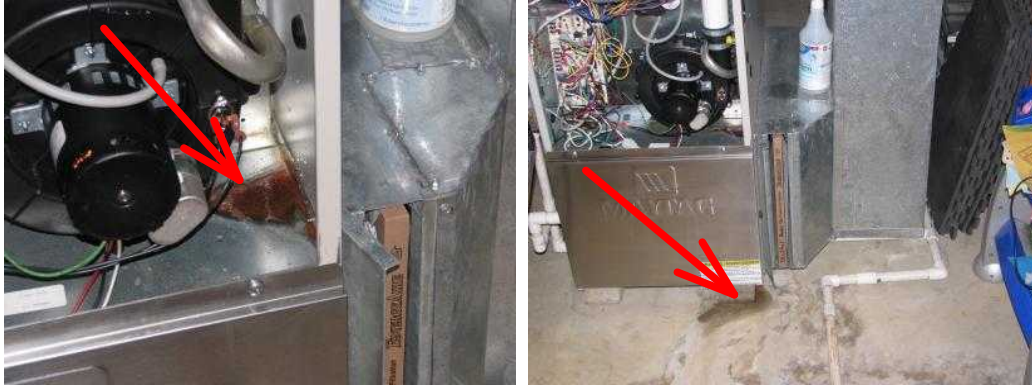
1. Heating System Operation: Condensate leakage noted in the furnace cabinet (first picture) and below the furnace (second picture) should be eliminated by a licensed HVAC contractor.

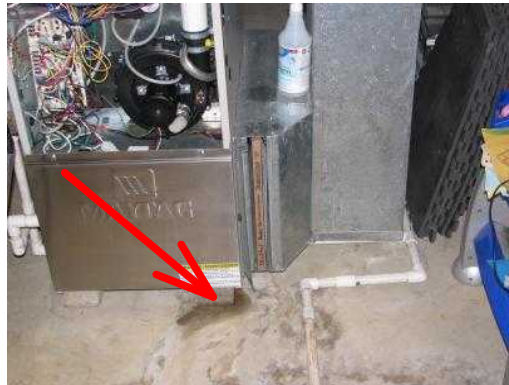
4. Heating System Heating System Operation: Condensate leakage noted in the furnace cabinet (first picture) and below the furnace (second picture) should be eliminated by a licensed HVAC contractor.

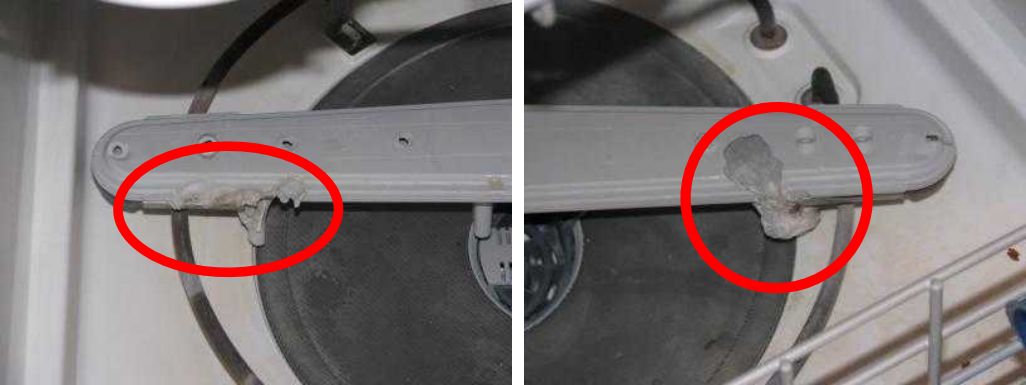
7. Kitchen Dishwasher: The dishwasher drain line should be elevated below the sink. The damaged dishwasher spray arm will require replacement by a qualified appliance repair person. (Pictures).
